Verity Rear Vision Systems strives to provide the highest quality to our customers. Our cameras are rated IP69K waterproof, which means they can withstand a 1,400 psi pressure spray with a fluid temperature of 150° F degrees.

Cable Tension

The Routing of a Cable Inside the Vehicle

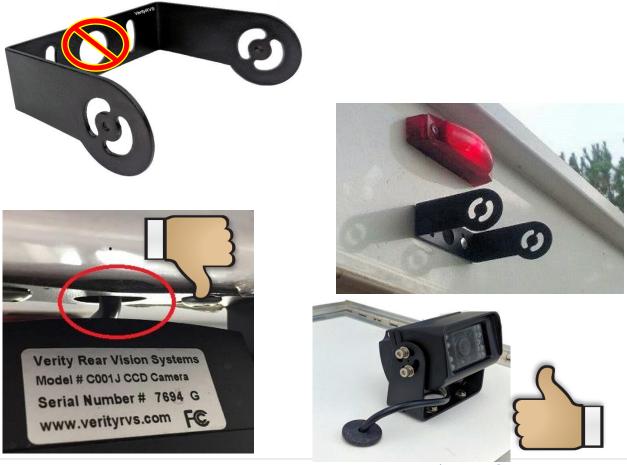
Damaged Seal & Using Center Hole Bracket Center Hole Mistakes

Too Much Cable Tension

The Center hole in the bracket is not the best way to insure not leaks in the camera cable. Below is the <u>suggested way</u> to install a bracket (not the hole in the center of the bracket.

Install a proper drip loop. When certain camera covers are used preventing a drip loop, provide ample slack as to not damage the rear camera seal. There is also a sealant inside the camera as a secondary seal against water penetration.

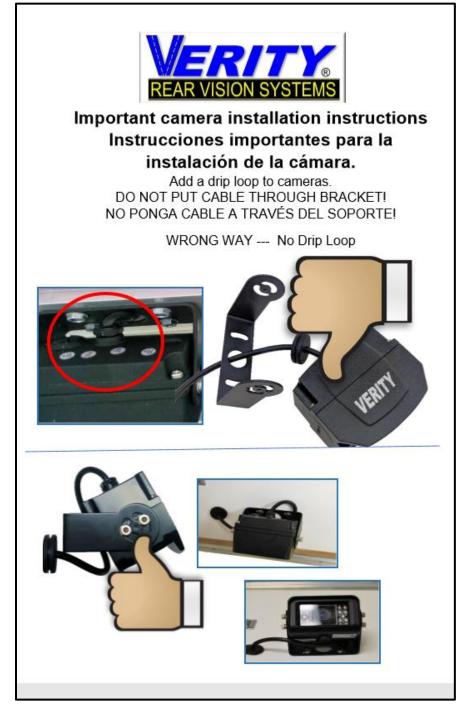
The image shown in figure the cable is coming through the wall and bending around the edge of the through hole which is represented in a red circle. The tension around that edge can damage the wiring inside the cable over time or even cause a cut in the cable.

The suggestions made by Verity RVS is to allow for a drip loop (i.e., slack) in the interior of the truck as shown in figure three. Also, putting wire loom on the camera cable where it comes in through the wall will help to protect the cable from being cut.
